# The New Hampshire Municipal Energy Assistance Program

## Decision Grade Audit Report

Albany Town Hall  
1972-B Route 16 Albany, NH 03818

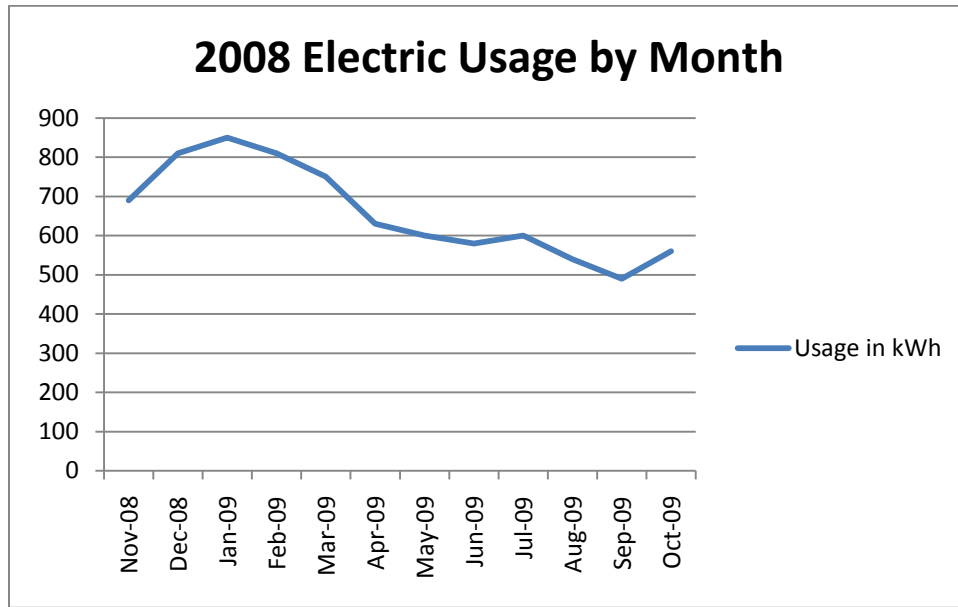
Graph 1

\*Graphs 1 and 2 were generated based on data retrieved from the EPA Portfolio Manager account for Albany, NH.

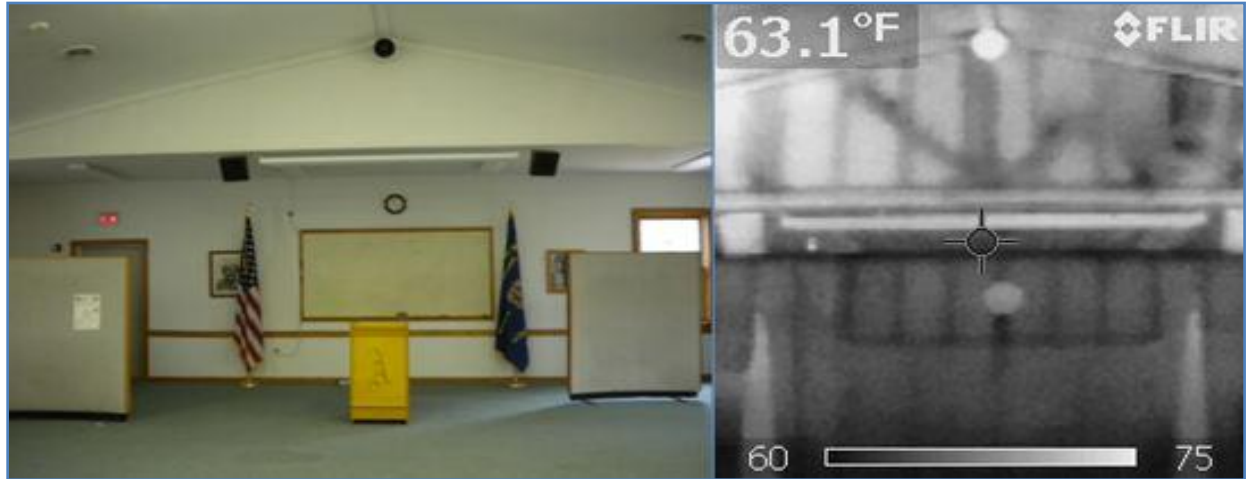
Figure 4

There are two small vertical sections of wall towards the ceiling on either side of the community room before the scissors trusses begin, visible in Figures 4 and 5 we would in this case consider them to be ceiling area and would recommend that air sealing and insulation work be done at the same time as the rest of the ceiling.

Figures 3, 4, and 5 illustrate the extensive amount of thermal bridging occurring in these walls. There is very little to be done to address the thermal bridging without going through a major renovation. Though taking measures to super insulate the exterior walls would be beneficial in regards to the long-term use of this building, there are many higher priority inefficiencies to be addressed first.

- Air seal any areas of infiltration from the exterior wall system. This would include, but not be limited to, electrical outlets, light switches and window/door trim.
- Super-insulate the exterior walls of the building. This should be done after all of the more easily implemented energy efficiency measures have been carried out. When ready to do this, the Town should consult with a building performance specialist to examine all the options and find the best fit for this building. The plan should incorporate continuous R-value, eliminating the extensive thermal bridging.

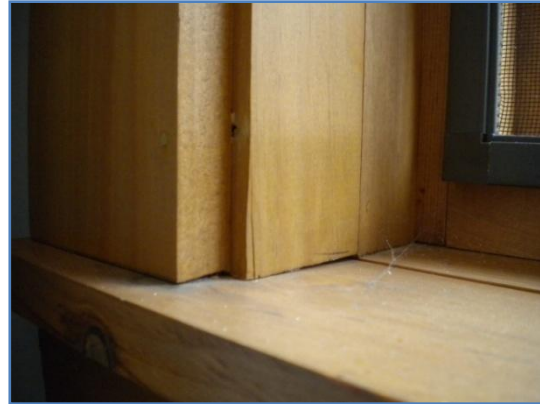
In Figure 15 we see small gaps between the sill, jamb and face trim. This is typical of exposed wood trim, especially as wood can shrink over time. Again, the problem comes from the insulation used behind this trim. There are several ways to stop this airflow. Sealing the cracks with wood putty would be a pain stacking process and not produce the best results. Caulking the cracks and painting the trim would also stop airflow, but would not add insulative value and would cover the aesthetic quality of the exposed wood grain. Carefully removing the trim, pulling the fiberglass out, and filling in the gaps spray foam insulation could be fairly easy and would produce the best long-term results.

- Weatherize all the doors and windows to ensure a good air seal when they are closed.
- Stop the air from infiltrating from around the window trim. The best method may be to temporarily remove the trim, remove the fiberglass insulation and fill the gaps with spray foam.

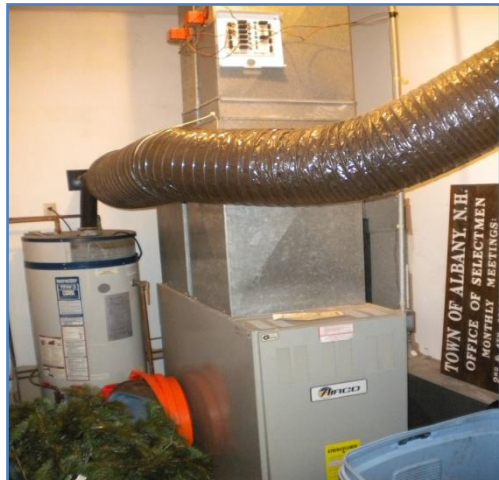
Figure 18

Two different types of heating system, running on two different fuels, heat this building. The primary system is an oil-fired furnace seen in Figure 18. The second are two wall mounted propane fired space heaters, one in each of the main office spaces. See Figure 19.

The oil furnace has two zones, one providing heat to the community room, lavatories and kitchen. The other zone supplies hot air to the office spaces. Mechanical zone dampers work in conjunction with the two thermostats, controlling the flow of air to both zones. Zone 1 (community room) has a thermostat located outside of the mechanical room, while Zone 2 (offices) has a thermostat located in the main hall between the offices. The thermostat controlling Zone 1 is turned down substantially while the room is not in use. Though this may be a large amount of time during the heating season, it still takes quite a bit of energy to keep

There is a propane-fired hot water heater visible in Figure 18. This unit is capable of producing a large amount of hot water and maintaining the temperature of this large tank may not be very practical given the relatively small amount of hot water use in this building. Also noted are the

uninsulated hot water pipes. Though it is difficult to say how much could be saved from switching to a more efficient system, a propane-fired tankless hot water heater could yield significant savings.

- Replace the two thermostats with 7-day programmable units to ensure maximum savings from reduced temperature settings.
- Replace the current hot water heater with a tankless LP fired system.

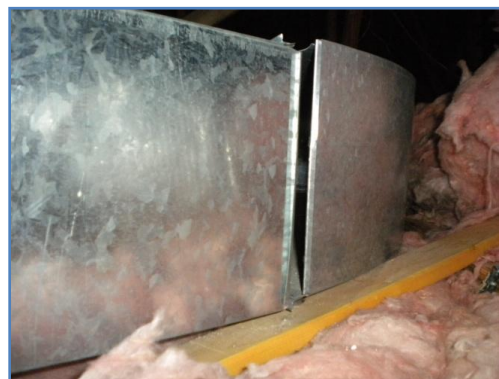
Figure 20

Almost all of the ductwork in this building is located outside of the thermal boundary in the attic space. None of the ductwork has been sealed, and a small percentage of the ductwork has any insulation. Insulation on unsealed ductwork has little positive effect. This is likely the single largest inefficiency of this building.

When entering the attic space, one of the first things we noticed is seen in Figure 20. Here we have two sections of duct that have not been sealed and are actually missing the slide that is supposed to hold them together.

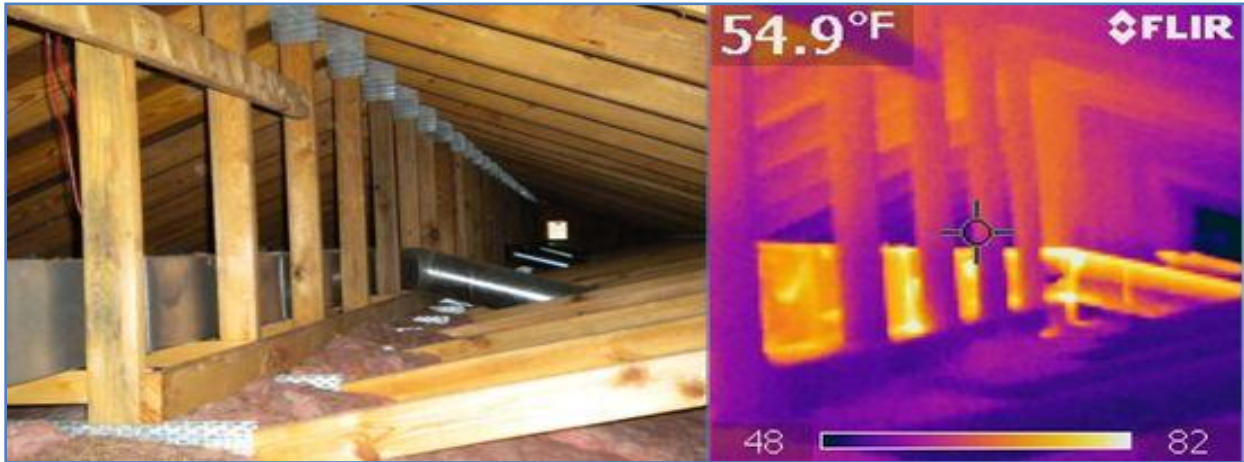
Figure 23

Figures 23 and 24 show views from the right and left sides of the Zone 1 supply air trunk. This ductwork is positioned in the well-vented attic space above the community room.

Unsealed, uninsulated ducts in a well-ventilated intermediate zone such as this effectively lose heat in three ways. First, the heated air in the supply ducts is under positive pressure and is forced out of the seams or separations in the ductwork. Second, return ducts are under negative pressure, sucking in cold air from the attic. This means that the normally room temperature air is being cooled before it is sent back through the heat exchanger. The third loss is that of radiant heat loss. As the heated air warms the very conductive metal duct, the heat radiates towards cold surfaces.

- Add 12 inches of loose fill cellulose to the entire ceiling area. Blow in additional amounts to the sides and top of all the ductwork (after all the duct work has been air sealed and insulated).

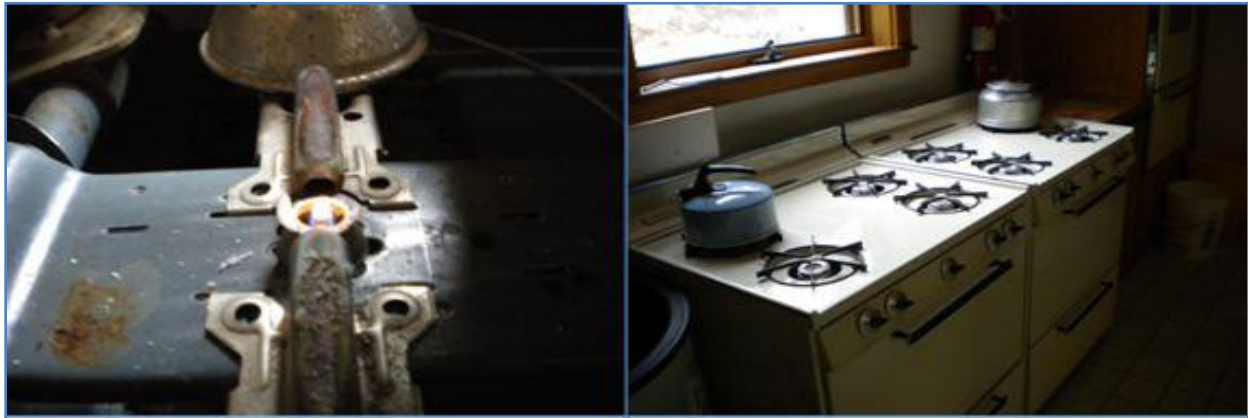
Figure 25

There are two gas stoves side by side in the kitchen. See Figure 25. These stoves are older models and have 3 pilot lights per unit that burn propane year round. The amount of standby gas that they consume is unknown, but any amount of wasted gas provides room for improvement.

- Replace the two kitchen stoves with units that have an electric spark ignition system.
